Area 2

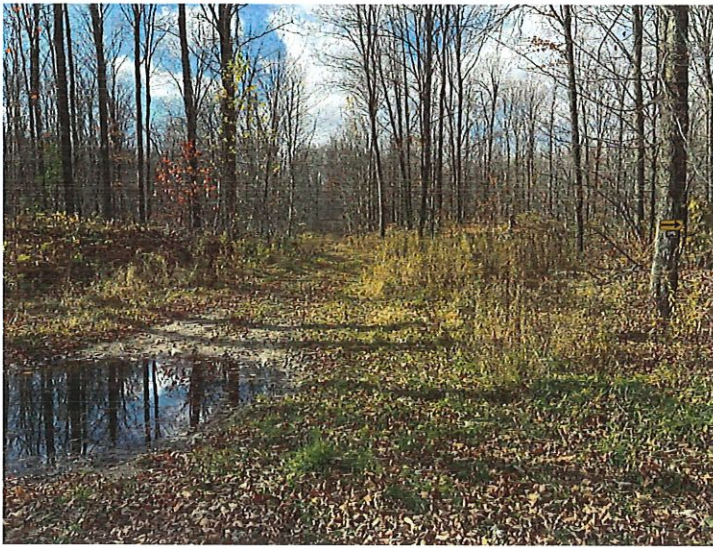
This area is **not closed**. Photo 1 shows access from ATV trail at road segment 3523. This is also accessible by all vehicles at road segment 1919. Invasive species are present primarily garlic mustard. These road are mostly below grade native silt soil surface the east side is generally dryer with some sand surface, the west side of this area having generally all silt soils. The east side is suitable for light traffic . Recommend no through traffic restriction on east side. The west side is not suitable for traffic with the last harvesting operation in this area had significant difficulty maintaining road 1914 and 811. Recommend full closure of 1914 and 811. All road segments are currently accessible by vehicle.
